# A geologic study of the Juan del Grijalva landslide, the most important mass movement during the last century in Mexico

Moisés Dávila Serrano · Oscar Jiménez

**Abstract** On November 4th 2007, along the Grijalva River in the state of Chiapas, Mexico, has occurred one of the largest landslides ever known. This landslide, known as *Juan del Grijalva*, destroyed the town of the same name, killing 20 people, and moved 55 million cubic meters of rock and debris down slope to completely block the Grijalva River. In order to understand the characteristics and factors that triggered the Juan del Grijalva landslide, geologic studies were conducted at the site. The results indicate that the landslide was composed of a lithologic sequence of thin-bedded shales and thin to medium-thick-bedded sandstones. This was faulted into several blocks dipping in the same sense as the mass movement. The main triggering factor was the increment of the pore pressure into the lithologic unit due to water saturation after 5 days of heavy rain before the incident. According to records from the last century, the Juan del Grijalva mass movement represents one of the largest mass movements recorded all over t

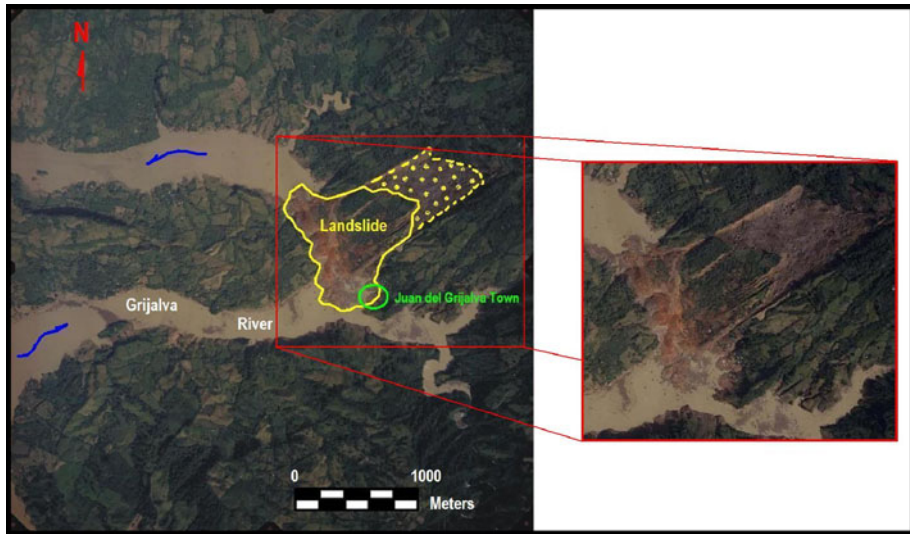
**Fig. 2** Aerial photograph showing the Juan del Grijalva Landslide and the course of the obstructed loop section of the Grijalva River. Photograph taken November 6, 2007, 2 days after the incident

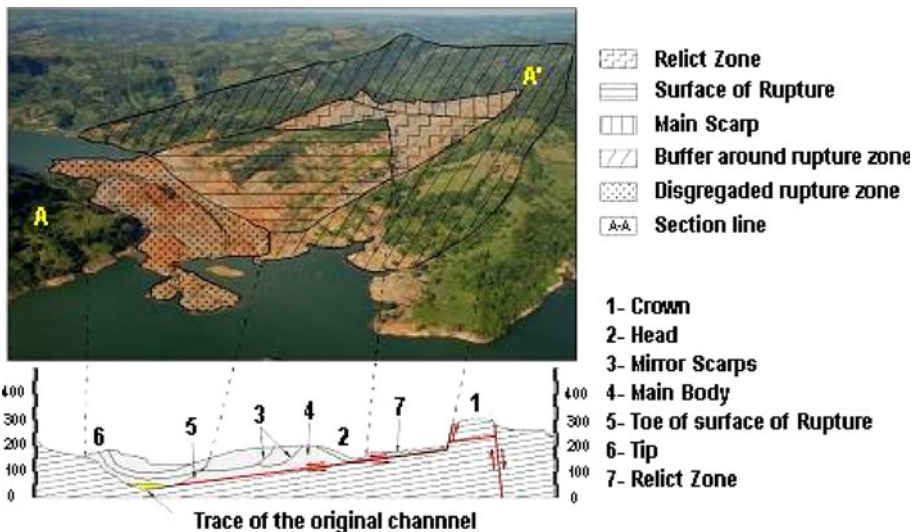
The surface mapping of the landslide shows the site morphology (Fig. 4) and how the material slid downward as a coherent unit, shoving the lower part outward and causing the debris to flow downhill. The front of the landslide formed a hummocky lobe that blocked the Grijalva River and stopped water from flowing downstream. The landslide moved more than 55,000,000 cubic meters of rock and debris along a horizontal distance of 500 m with about 140 m of vertical displacement (CFE, Comisión Federal de Electricidad 2008).

**Fig. 4** Morphology of the Juan del Grijalva landslide. See the obstruction of the river course and cross-section A–A' through the sliding zone. Nomenclature after Chacón et al. (1993)

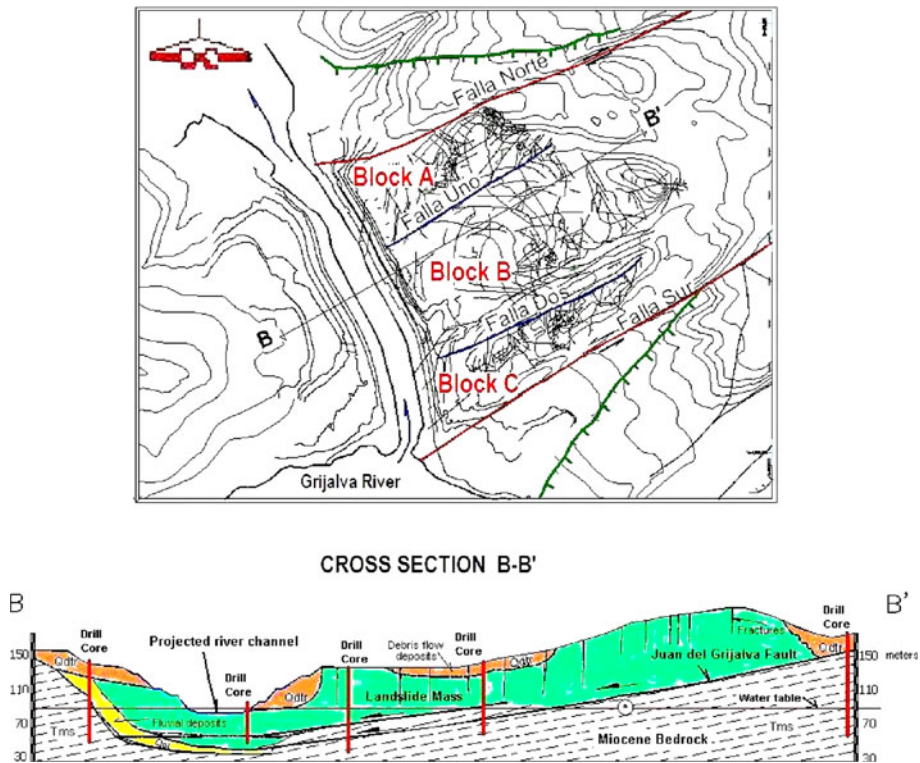
**Fig. 5** Main geologic features of the Juan del Grijalva Landslide. Falla Norte and Falla Sur bound the landslide on the north and south edges, respectively, and Fallas Uno and Dos are intermediate faults. Drill cores cut the path of the Juan del Grijalva *detachment* fault and the projected artificial river channel in cross-section B–B'

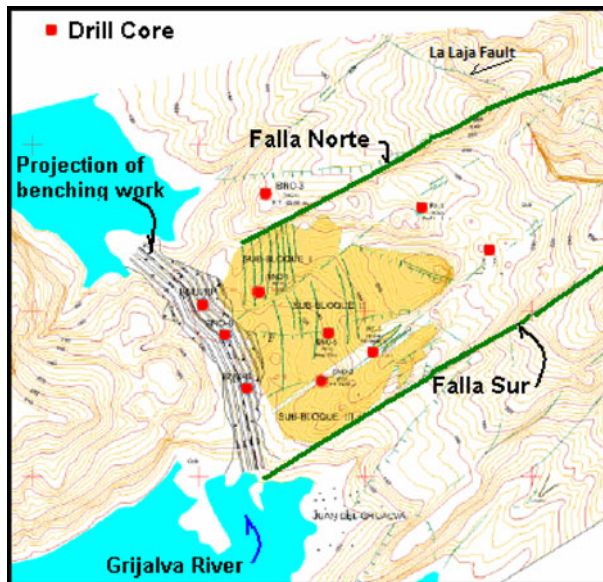
After the landslide event, ten exploration bore-holes were drilled (Fig. 6) and one electrical resistivity geophysical reconnaissance line survey was acquired. The objective was to determine the internal character of the landslide, specifically the geotechnical response of the ground to imposed conditions of stress, drainage, saturation, movement and removal of blocks. Based on core recovery, rock grade and fracture distribution, it was possible to discern the thickness and internal deformation in the landslide, as well as that the bedrock conditions were strong, with a bedrock mass as good as 100% rock quality in some volumes.

**Fig. 6** Location of drill cores in the Juan del Grijalva Landslide

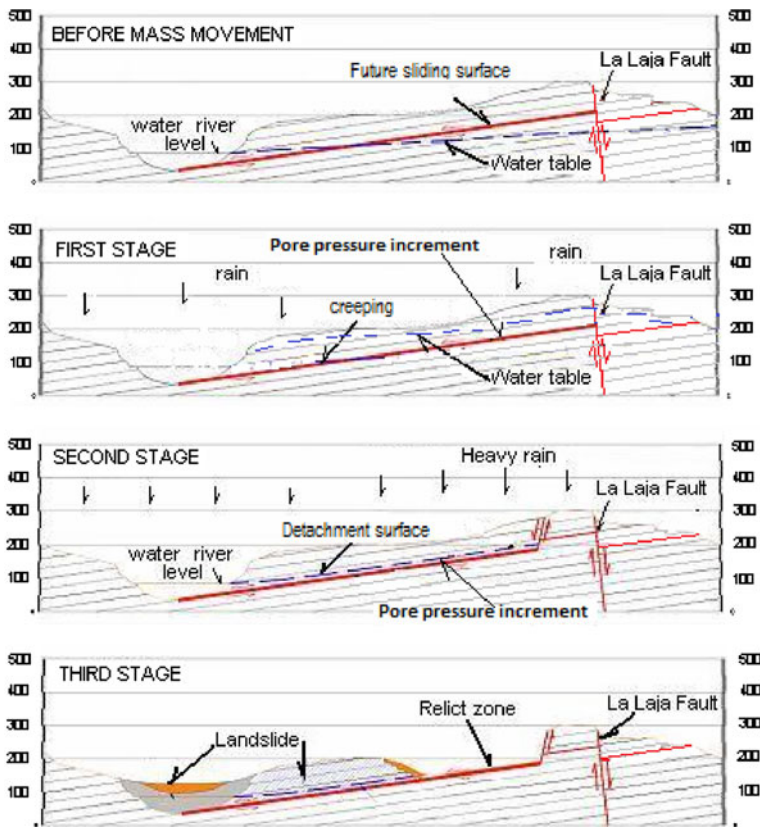
According to all previous factors, it is proposed here that the landslide gravity induced movement of the bedrock mass, followed three stages (Fig. 7).

In the first stage, before the detachment, the natural slope had a safety factor of 1.5 according to Carson and Kirkby (1972) scale. However, after 5 h of extreme rainfall, the rock composed of sandstone, shale, and unconsolidated materials absorbed water rainfall and started creep very slowly.

**Fig. 7** Schematic stage development during the down slope movement of the Juan del Grijalva Landslide

In the second stage, the pore pressure increment due to water saturation and weight caused a suddenly slid of the slope material. The safety factor decreased and the instability limit was reached because the initial shear resistance of the rock mass was overcome.

During the third and final stage of the process, the lower part of the landslide was transformed into a turbulent, viscous, heavy mass of rock fragments, debris, and soil that moved downward almost instantly. The mass movement caused a river water wave 50 m high and filled up the complete watercourse valley.
