# A geologic study of the Juan del Grijalva landslide, the most important mass movement during the last century in Mexico

Moisés Dávila Serrano · Oscar Jiménez

**Abstract** On November 4th 2007, along the Grijalva River in the state of Chiapas, Mexico, has occurred one of the largest landslides ever known. This landslide, known as *Juan del Grijalva*, destroyed the town of the same name, killing 20 people, and moved 55 million cubic meters of rock and debris down slope to completely block the Grijalva River. In order to understand the characteristics and factors that triggered the Juan del Grijalva landslide, geologic studies were conducted at the site. The results indicate that the landslide was composed of a lithologic sequence of thin-bedded shales and thin to medium-thick-bedded sandstones. This was faulted into several blocks dipping in the same sense as the mass movement. The main triggering factor was the increment of the pore pressure into the lithologic unit due to water saturation after 5 days of heavy rain before the incident. According to records from the last century, the Juan del Grijalva mass movement represents one of the largest mass movements recorded all over t

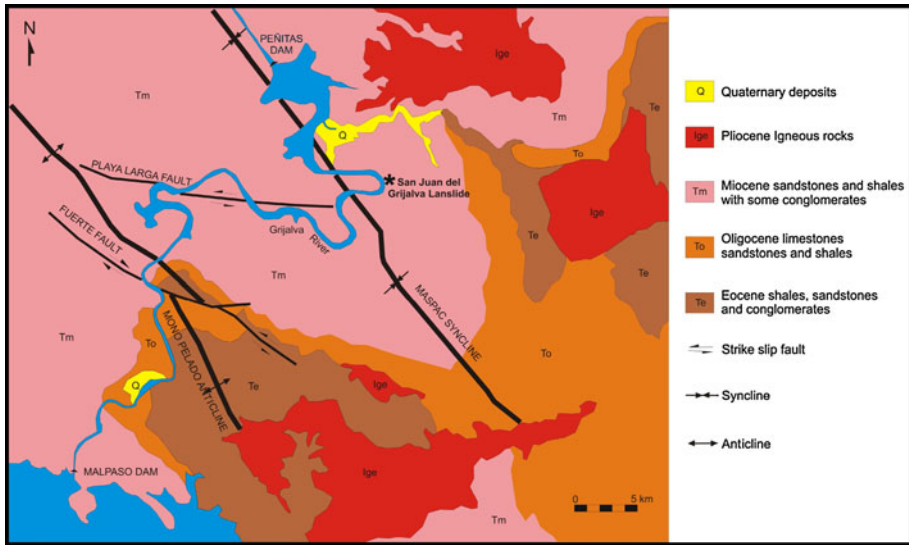
Geologic mapping in the region indicates that a single stratigraphic unit constitutes both the bedrock and the landslide (Fig. 3). The unit of Miocene age is formed by thin to medium-bedded ochre-colored sandstones and very thin to thin dark gray shales. At the base of the unit, there are some layers of very coarse to pebbly sandstones and brown conglomerates. The strike of the sedimentary unit is N340 dipping between 8° and 15° southwestward, as part of the northeastern limb of the Maspac Syncline.

**Fig. 3** Simplified regional geologic map of the area surrounding the Juan del Grijalva Landslide, Chiapas, Mexico (CFE—Comisión Federal de Electricidad 2008). Note the location of the Malpasí and Peritas dams
